Thermal imaging survey report

Cromarty Hall, St Margaret's Hope

Thursday, February 27, 2025

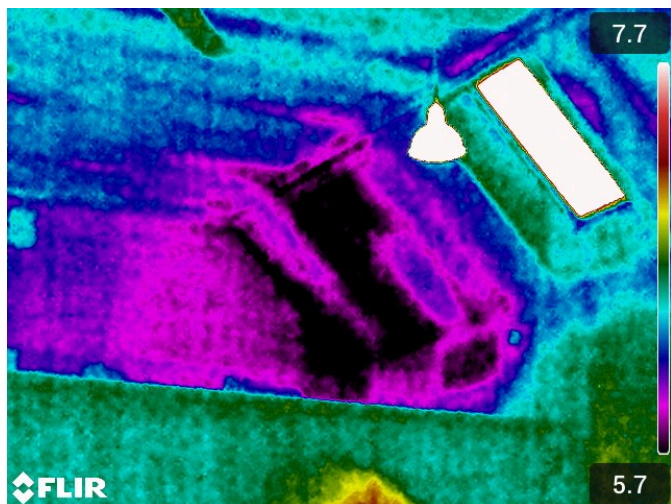
Survey item	Location	Anomaly
Main room	Comarty Hall, St Margaret's Hope	Yes

Min. temp.	5.7°C
Max. temp.	7.7°C

Evidence of heat loss in area of sloped ceiling on the north side of the hall, above the balcony.

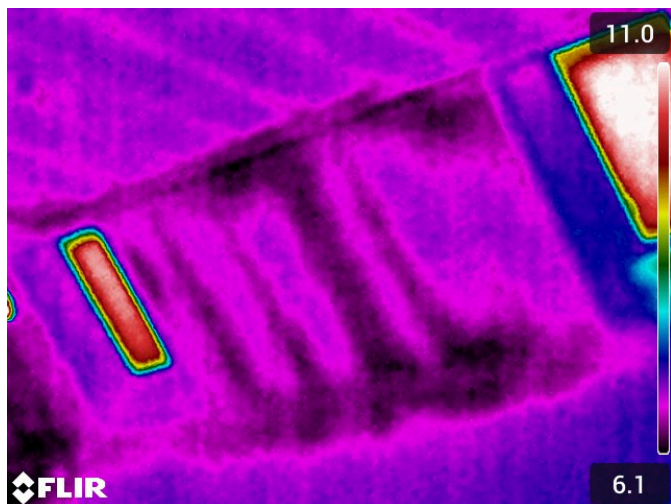
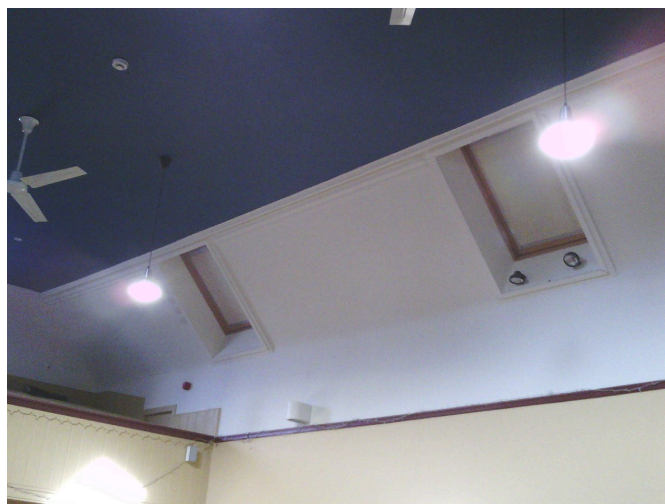
Survey item	Location	Anomaly
Main room	Cromarty Hall, St Margaret's Hope	Yes

Min. temp.	6.1°C
Max. temp.	11.0°C

Evidence of heat loss on area of sloped ceiling, between skylights on north side of the main hall.

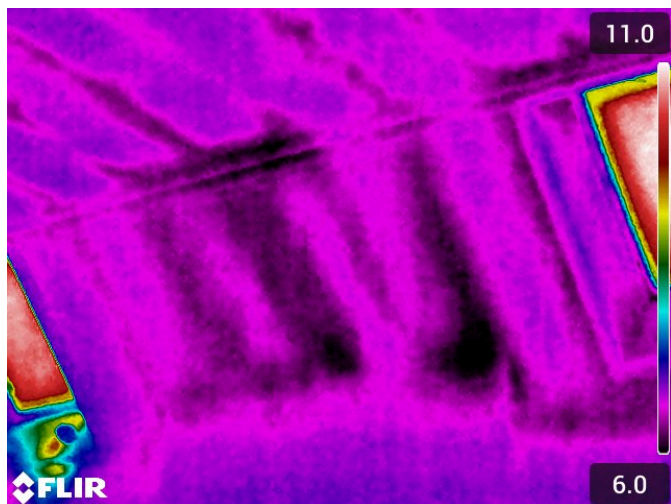
Survey item	Location	Anomaly
Main room	Cromarty Hall, St Margaret's Hope	Yes

Min. temp.	6.0°C
Max. temp.	11.0°C

Evidence of heat loss on area of sloped ceiling, between skylights on north side of the main hall.

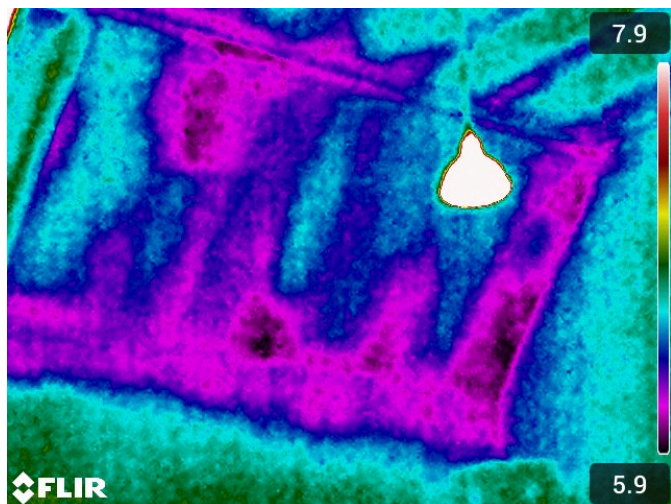
Survey item	Location	Anomaly
Main room	Cromarty Hall, St Margaret's Hope	Yes

Min. temp.	5.9°C
Max. temp.	7.9°C

Evidence of heat loss on area of sloped ceiling, next to stage in main hall.

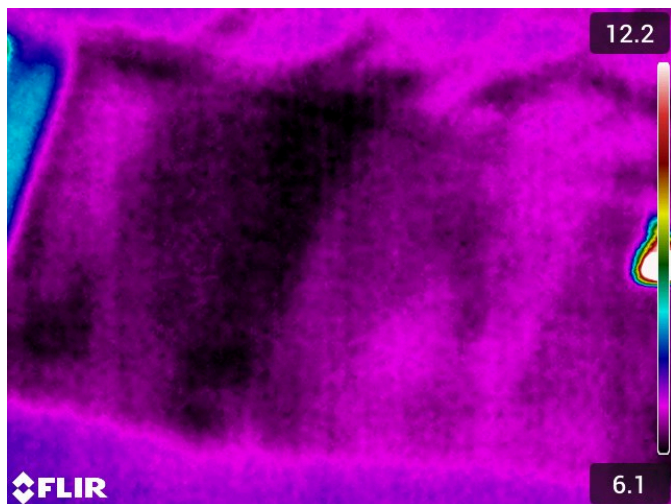
Survey item	Location	Anomaly
Main room	Cromarty Hall, St Margaret's Hope	Yes

Min. temp.	6.1°C
Max. temp.	12.2°C

Evidence of heat loss on area of sloped ceiling, between skylights on south side of the main hall.

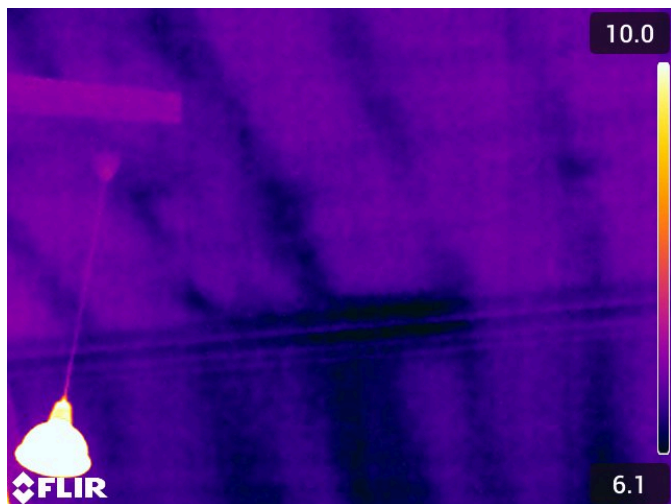
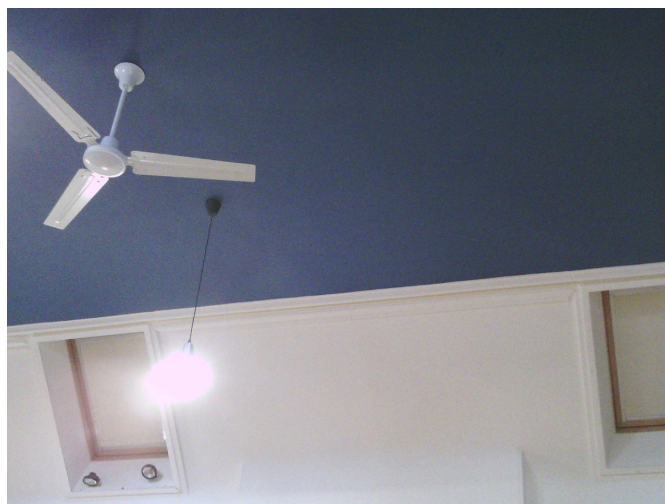
Survey item	Location	Anomaly
Main room	Cromarty Hall, St Margaret's Hope	Yes

Min. temp.	6.1°C
Max. temp.	10.0°C

Evidence of heat loss at wall ceiling joint on north side of main hall.

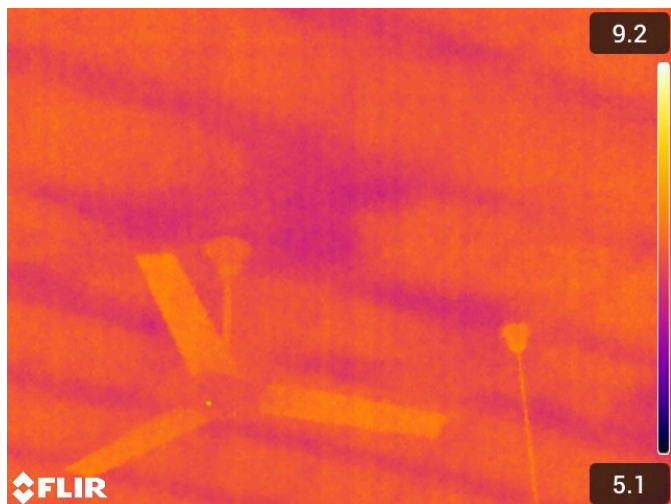
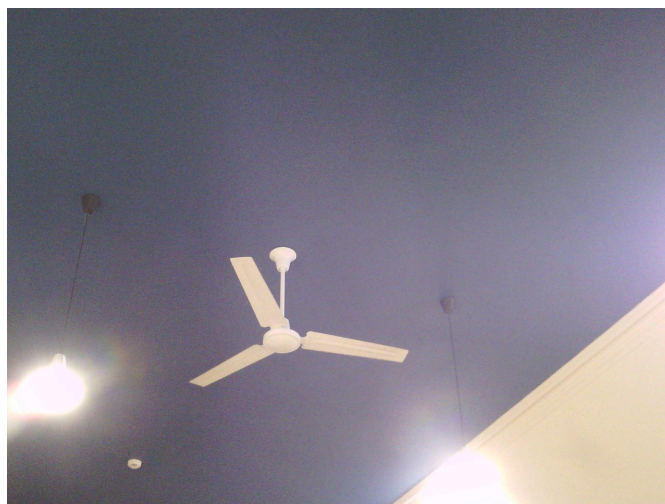
Survey item	Location	Anomaly
Main room	Cromarty Hall, St Margaret's Hope	Yes

Min. temp.	5.1°C
Max. temp.	9.2°C

Thermal pattern suggests area of poor insulation next to ceiling fan.

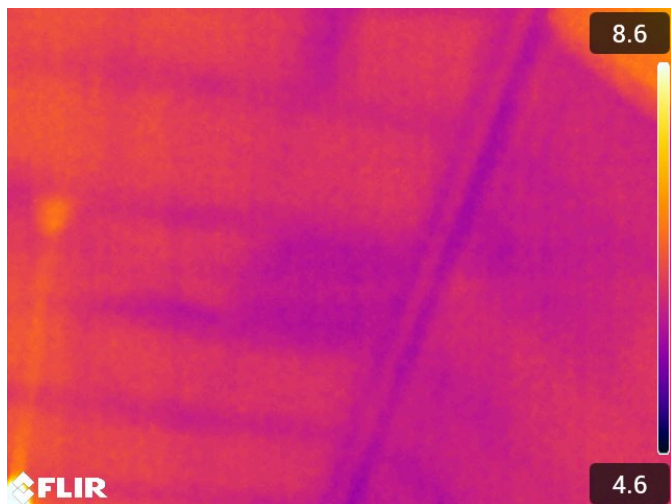
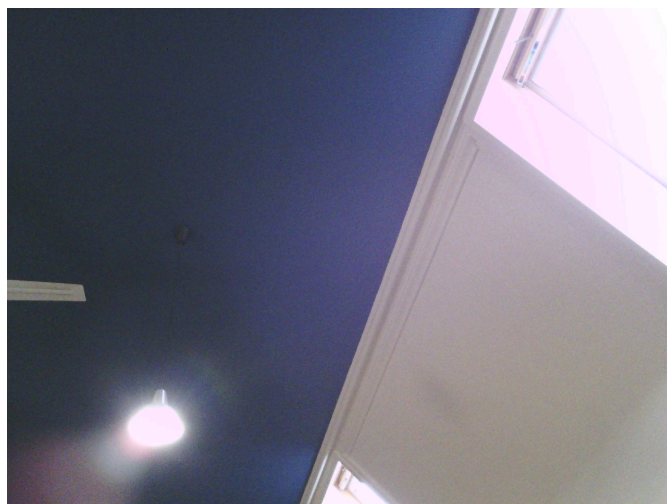
Survey item	Location	Anomaly
Main room	Cromarty Hall, St Margaret's Hope	Yes

Min. temp.	4.6°C
Max. temp.	8.6°C

Area of heat loss; thermal pattern suggests poor insulation.

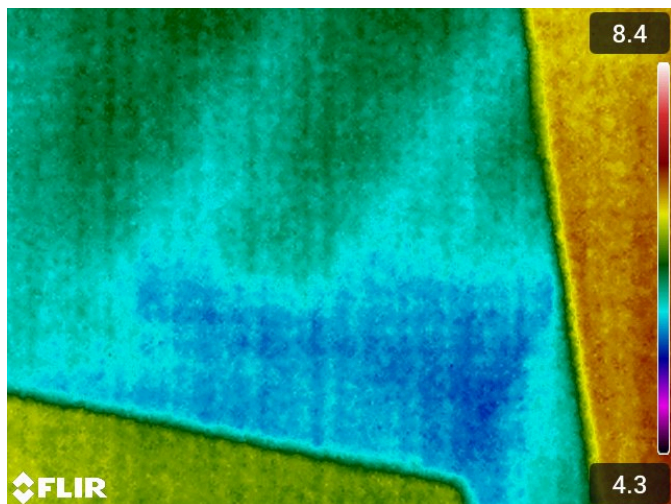
Survey item	Location	Anomaly
Main room (stage)	Cromarty Hall, St Margaret's Hope	Yes

Min. temp.	4.3°C
Max. temp.	8.4°C

Area of heat loss on sloped ceiling, on the north side of the main hall stage.

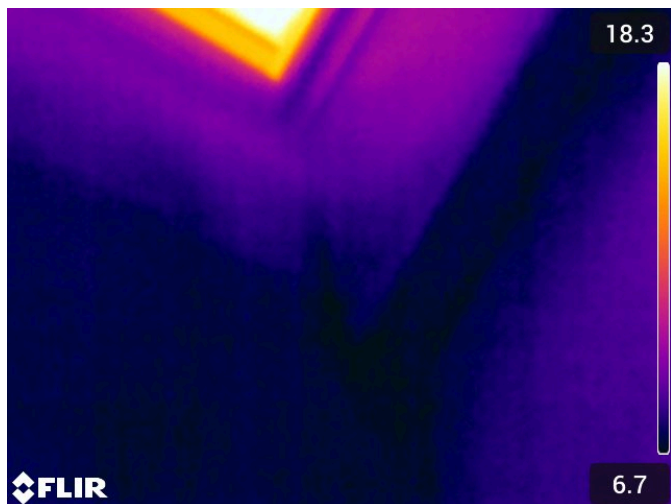
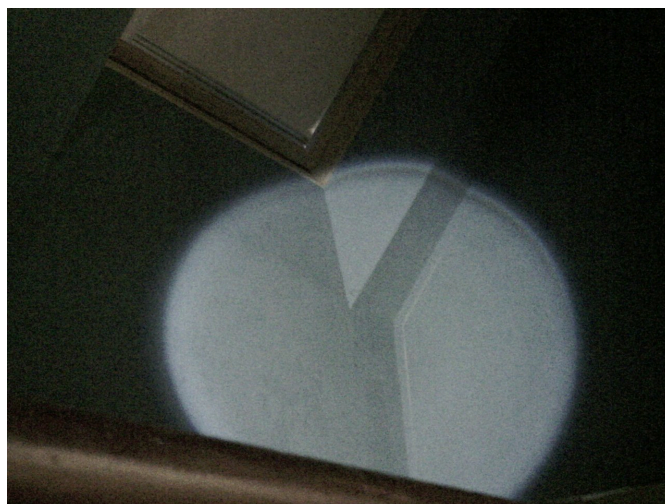
Survey item	Location	Anomaly
Main room (stage)	Cromarty Hall, St Margaret's Hope	Yes

Min. temp.	6.7°C
Max. temp.	18.3°C

Evidence of heat loss from area below skylight on north side of stage.

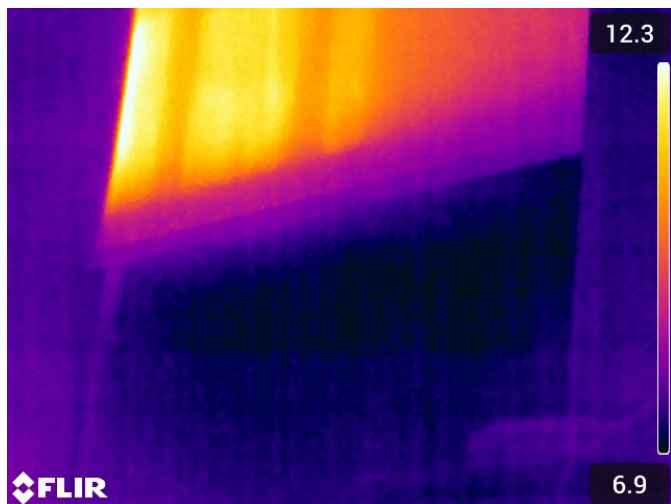
Survey item	Location	Anomaly
Main room (stage)	Cromarty Hall, St Margaret's Hope	Yes

Area of heat loss from below window at the rear of the stage. Thermal pattern suggests poor insulation below the window.

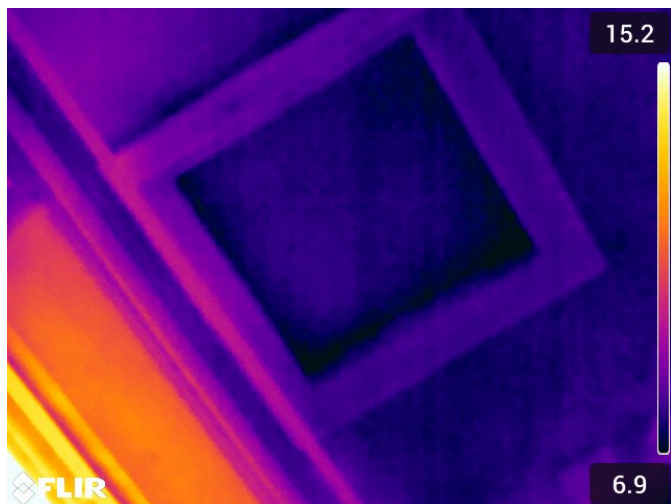
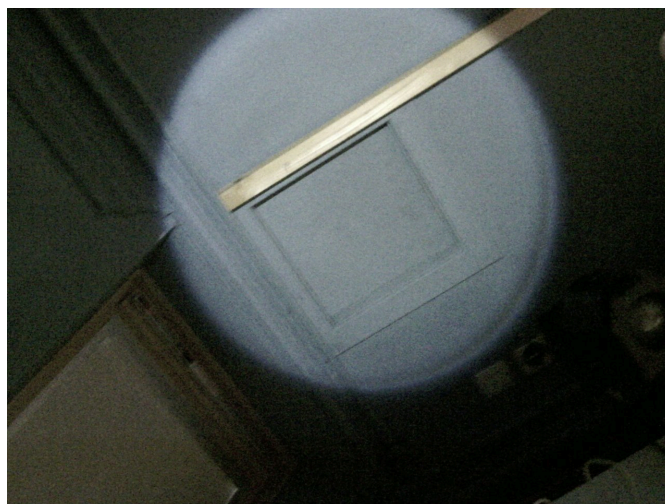
Survey item	Location	Anomaly
Main room (stage)	Cromarty Hall, St Margaret's Hope	Yes

Thermal pattern suggests cold air leakage from attic hatch on north side of stage.

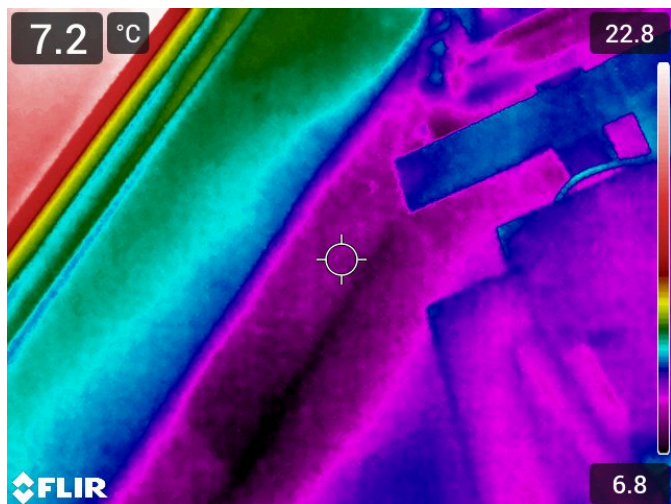
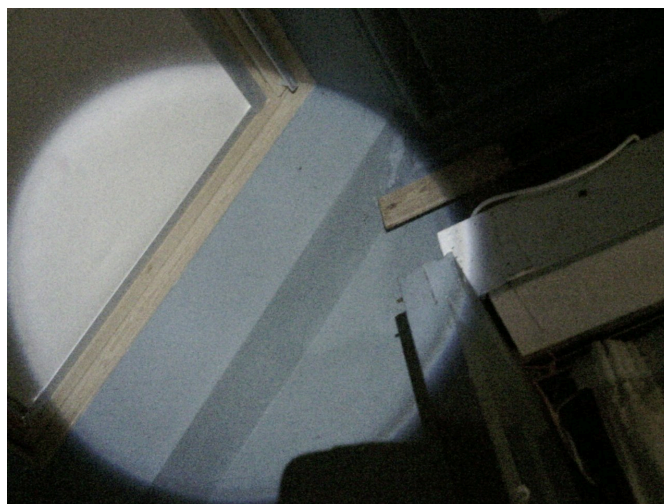
Survey item	Location	Anomaly
Main room (stage)	Cromarty Hall, St Margaret's Hope	Yes

Evidence of heat loss to the right of skylight above the stage.

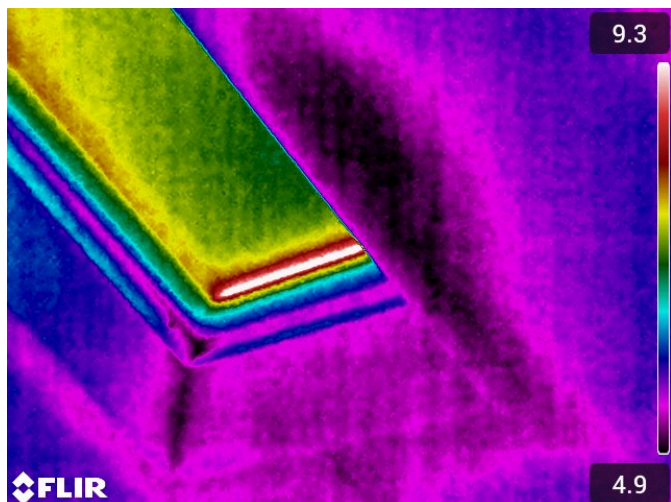
Survey item	Location	Anomaly
Bar / meeting room	Cromarty Hall, St Margaret's Hope	Yes

Evidence of heat loss to the right of skylight in bar / meeting room.

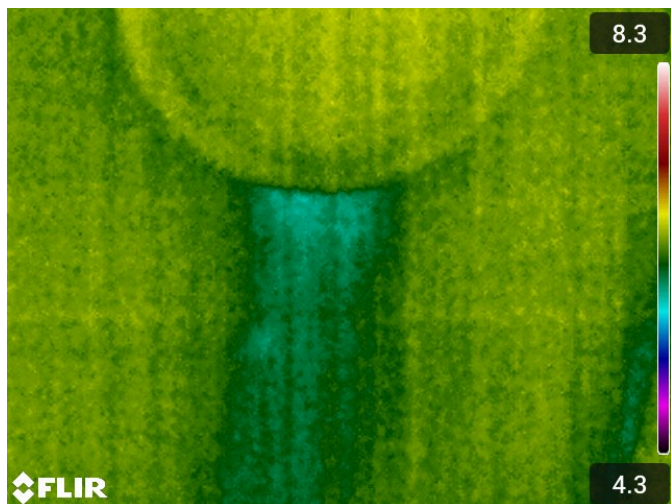
Survey item	Location	Anomaly
Bar / meeting room toilet	Cromarty Hall, St Margaret's Hope	Yes

Area below light in bar / meeting room toilet. Thermal pattern suggests cold air entering below the light fitting.

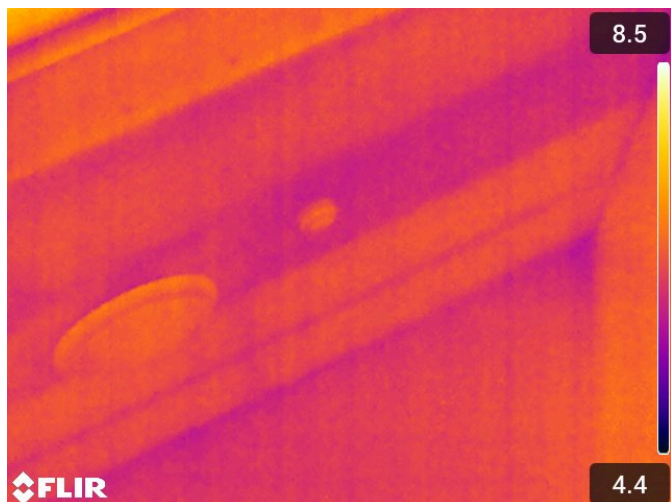
Survey item	Location	Anomaly
Bar / meeting room	Cromarty Hall, St Margaret's Hope	Yes

Area of heat loss in line with light fitting in bar / meeting room. Thermal pattern suggests poor insulation in this area.

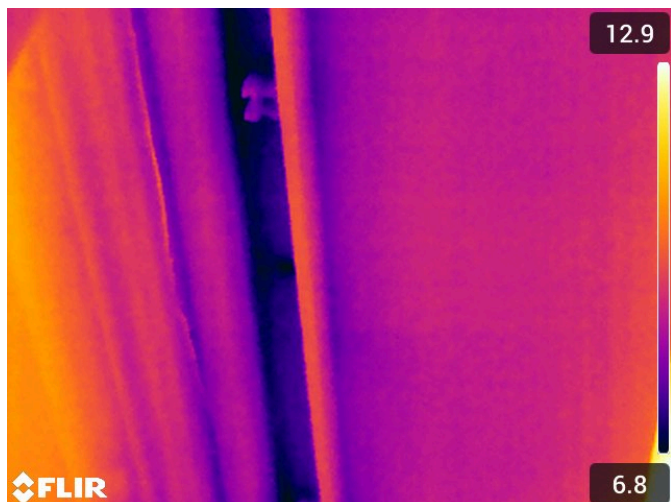
Survey item	Location	Anomaly
Dressing / book room	Cromarty Hall, St Margaret's Hope	Yes

This image shows the left-hand (from inside) window in the dressing / book room. Thermal pattern suggests cold air is entering the building at the window seal. Mould also observed at the top of the window frame. The following image, of the right-hand window is shown for comparison — little or no cold air ingress.

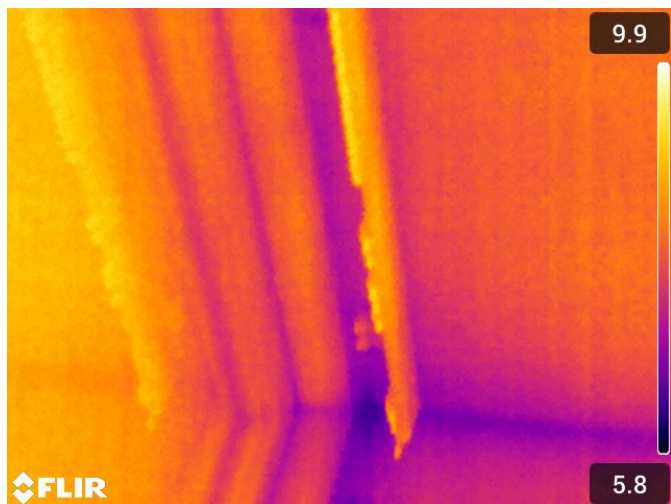
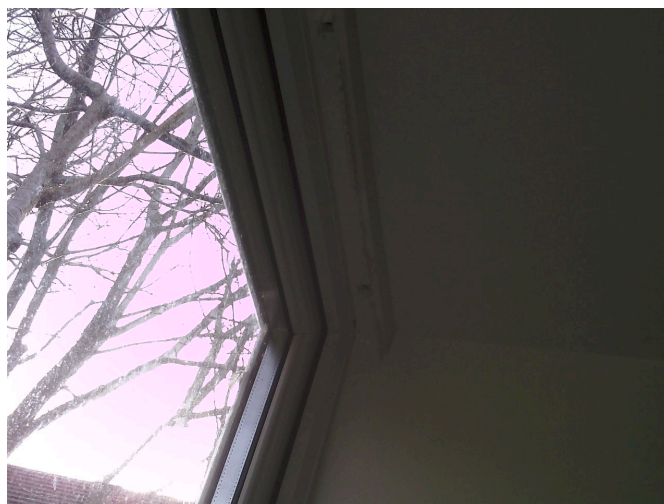
Survey item	Location	Anomaly
Dressing / book room	Cromarty Hall, St Margaret's Hope	Yes

This image shows the right-hand (from inside) window in the dressing / book room. As mentioned in the previous comment, little or no cold air ingress can be seen. It was also noted that there was no mould on this window.

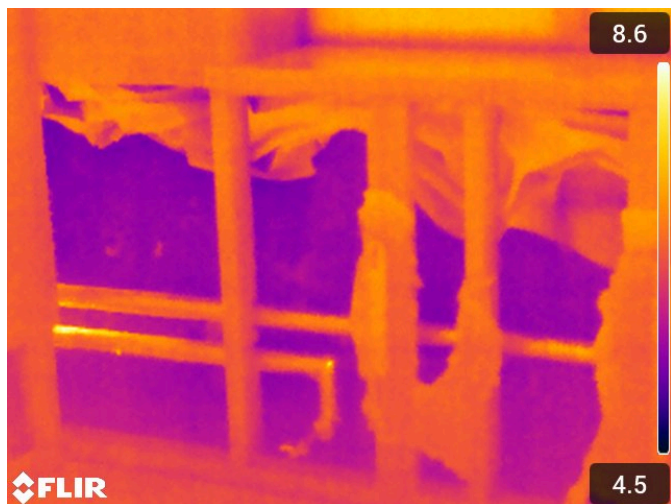
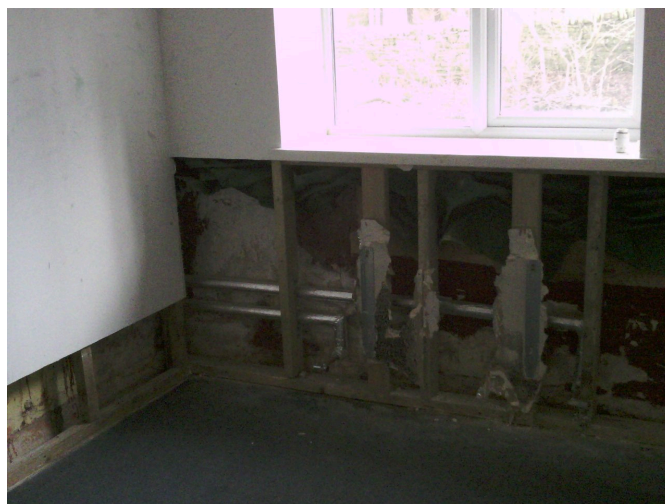
Survey item	Location	Anomaly
Store	Cromarty Hall, St Margaret's Hope	Yes

Images show missing plasterboard in the store. The lack of insulation in this area will result in significant heat loss.

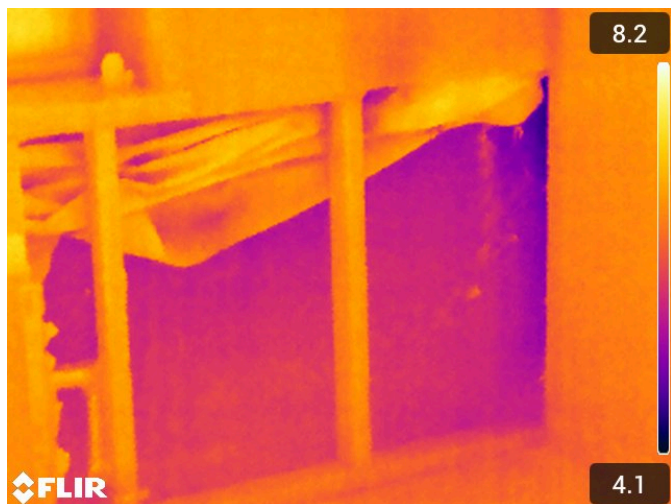
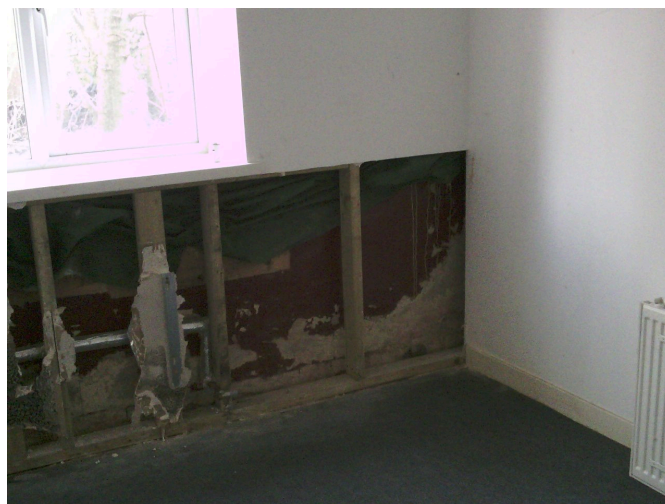
Survey item	Location	Anomaly
Store	Cromarty Hall, St Margaret's Hope	Yes

Additional images of the missing plasterboard, and resultant heat loss, in the store.

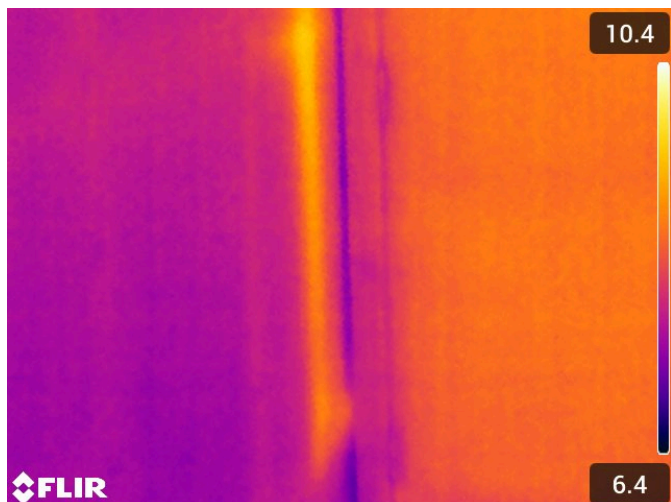
Survey item	Location	Anomaly
Hallway	Cromarty Hall, St Margaret's Hope	Yes

Additional image of the warm area in the hallway, likely caused by heat from hot water pipes.

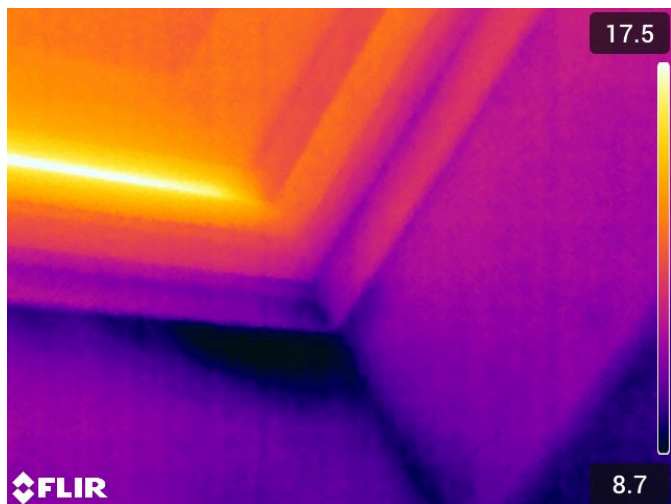
Survey item	Location	Anomaly
Yoga room	Cromarty Hall, St Margaret's Hope	Yes

This image shows the first window on the left, on the east wall of the yoga room. The thermal image shows a cold area at the bottom right of the skylight. This could be caused by cold air or a thermal bridge in that area.

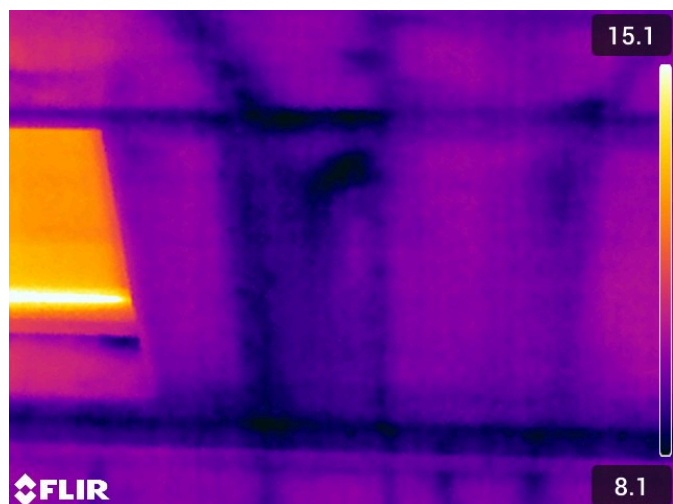
Survey item	Location	Anomaly
Yoga room	Cromarty Hall, St Margaret's Hope	Yes

Thermal bridge noted in the yoga room to the right of the first-right skylight.

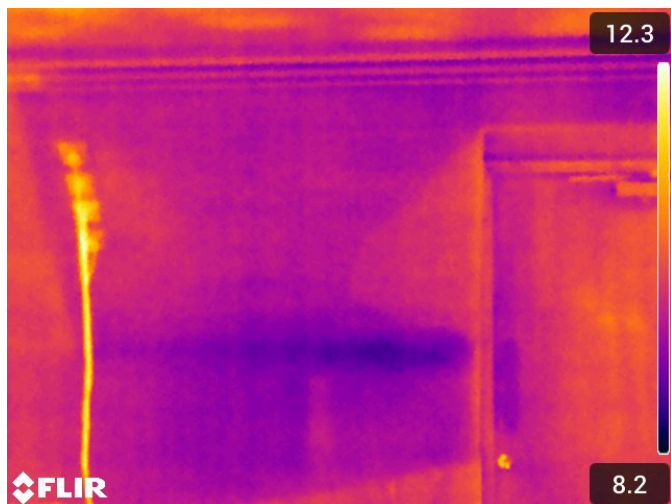
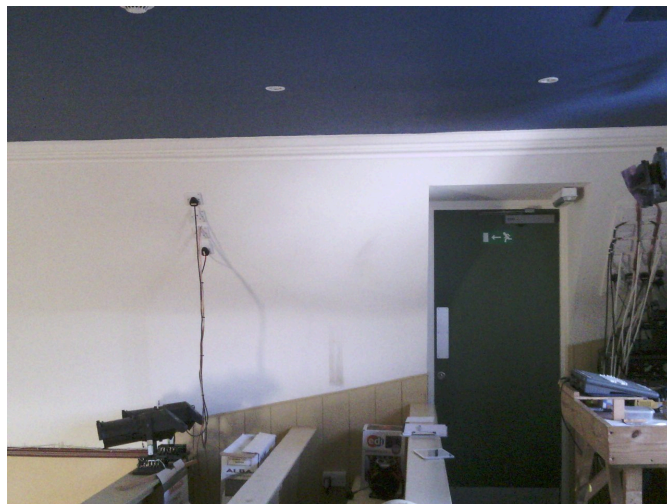
Survey item	Location	Anomaly
Balcony	Cromarty Hall, St Margaret's Hope	Yes

Image shows the area of sloped ceiling on the south side of the balcony. This area of sloped ceiling, and also the area on the north side of the balcony, are colder than the rest of the ceiling in the main hall. This suggests a lack of insulation in the sloped ceiling above the balcony. Also, note the thermal pattern to the left of the door; this curved area has defined edges, suggesting it may be due to moisture. There is also discolouration noted on the wall on the leading edge of the curved area. This anomaly should be further investigated to understand the cause.

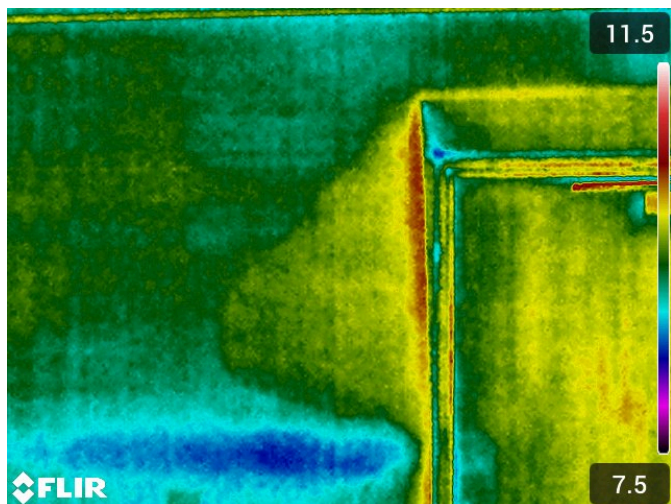
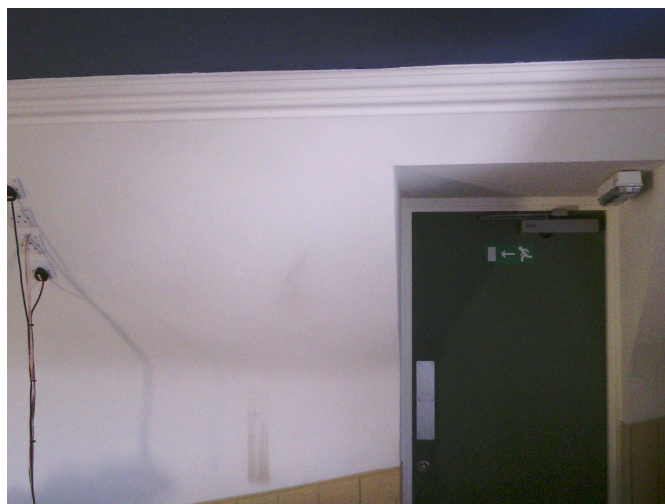
Survey item	Location	Anomaly
Balcony	Cromarty Hall, St Margaret's Hope	Yes

Image shows the area of sloped ceiling on the south side of the balcony. This area of sloped ceiling, and also the area on the north side of the balcony, are colder than the rest of the ceiling in the main hall. This suggests a lack of insulation in the sloped ceiling above the balcony. Also, note the thermal pattern to the left of the door; this curved area has defined edges, suggesting it may be due to moisture. There is also discolouration noted on the wall on the leading edge of the curved area. This anomaly should be further investigated to understand the cause.
